LANDSLIDES AND RELATED FEATURES

LA FOLLETTE, TENN. QUADRANGLE Roger E. Thomas and Alfred R. Taylor

1982

U.S. Geological Survey OPEN FILE MAP 82-653 (D-16)

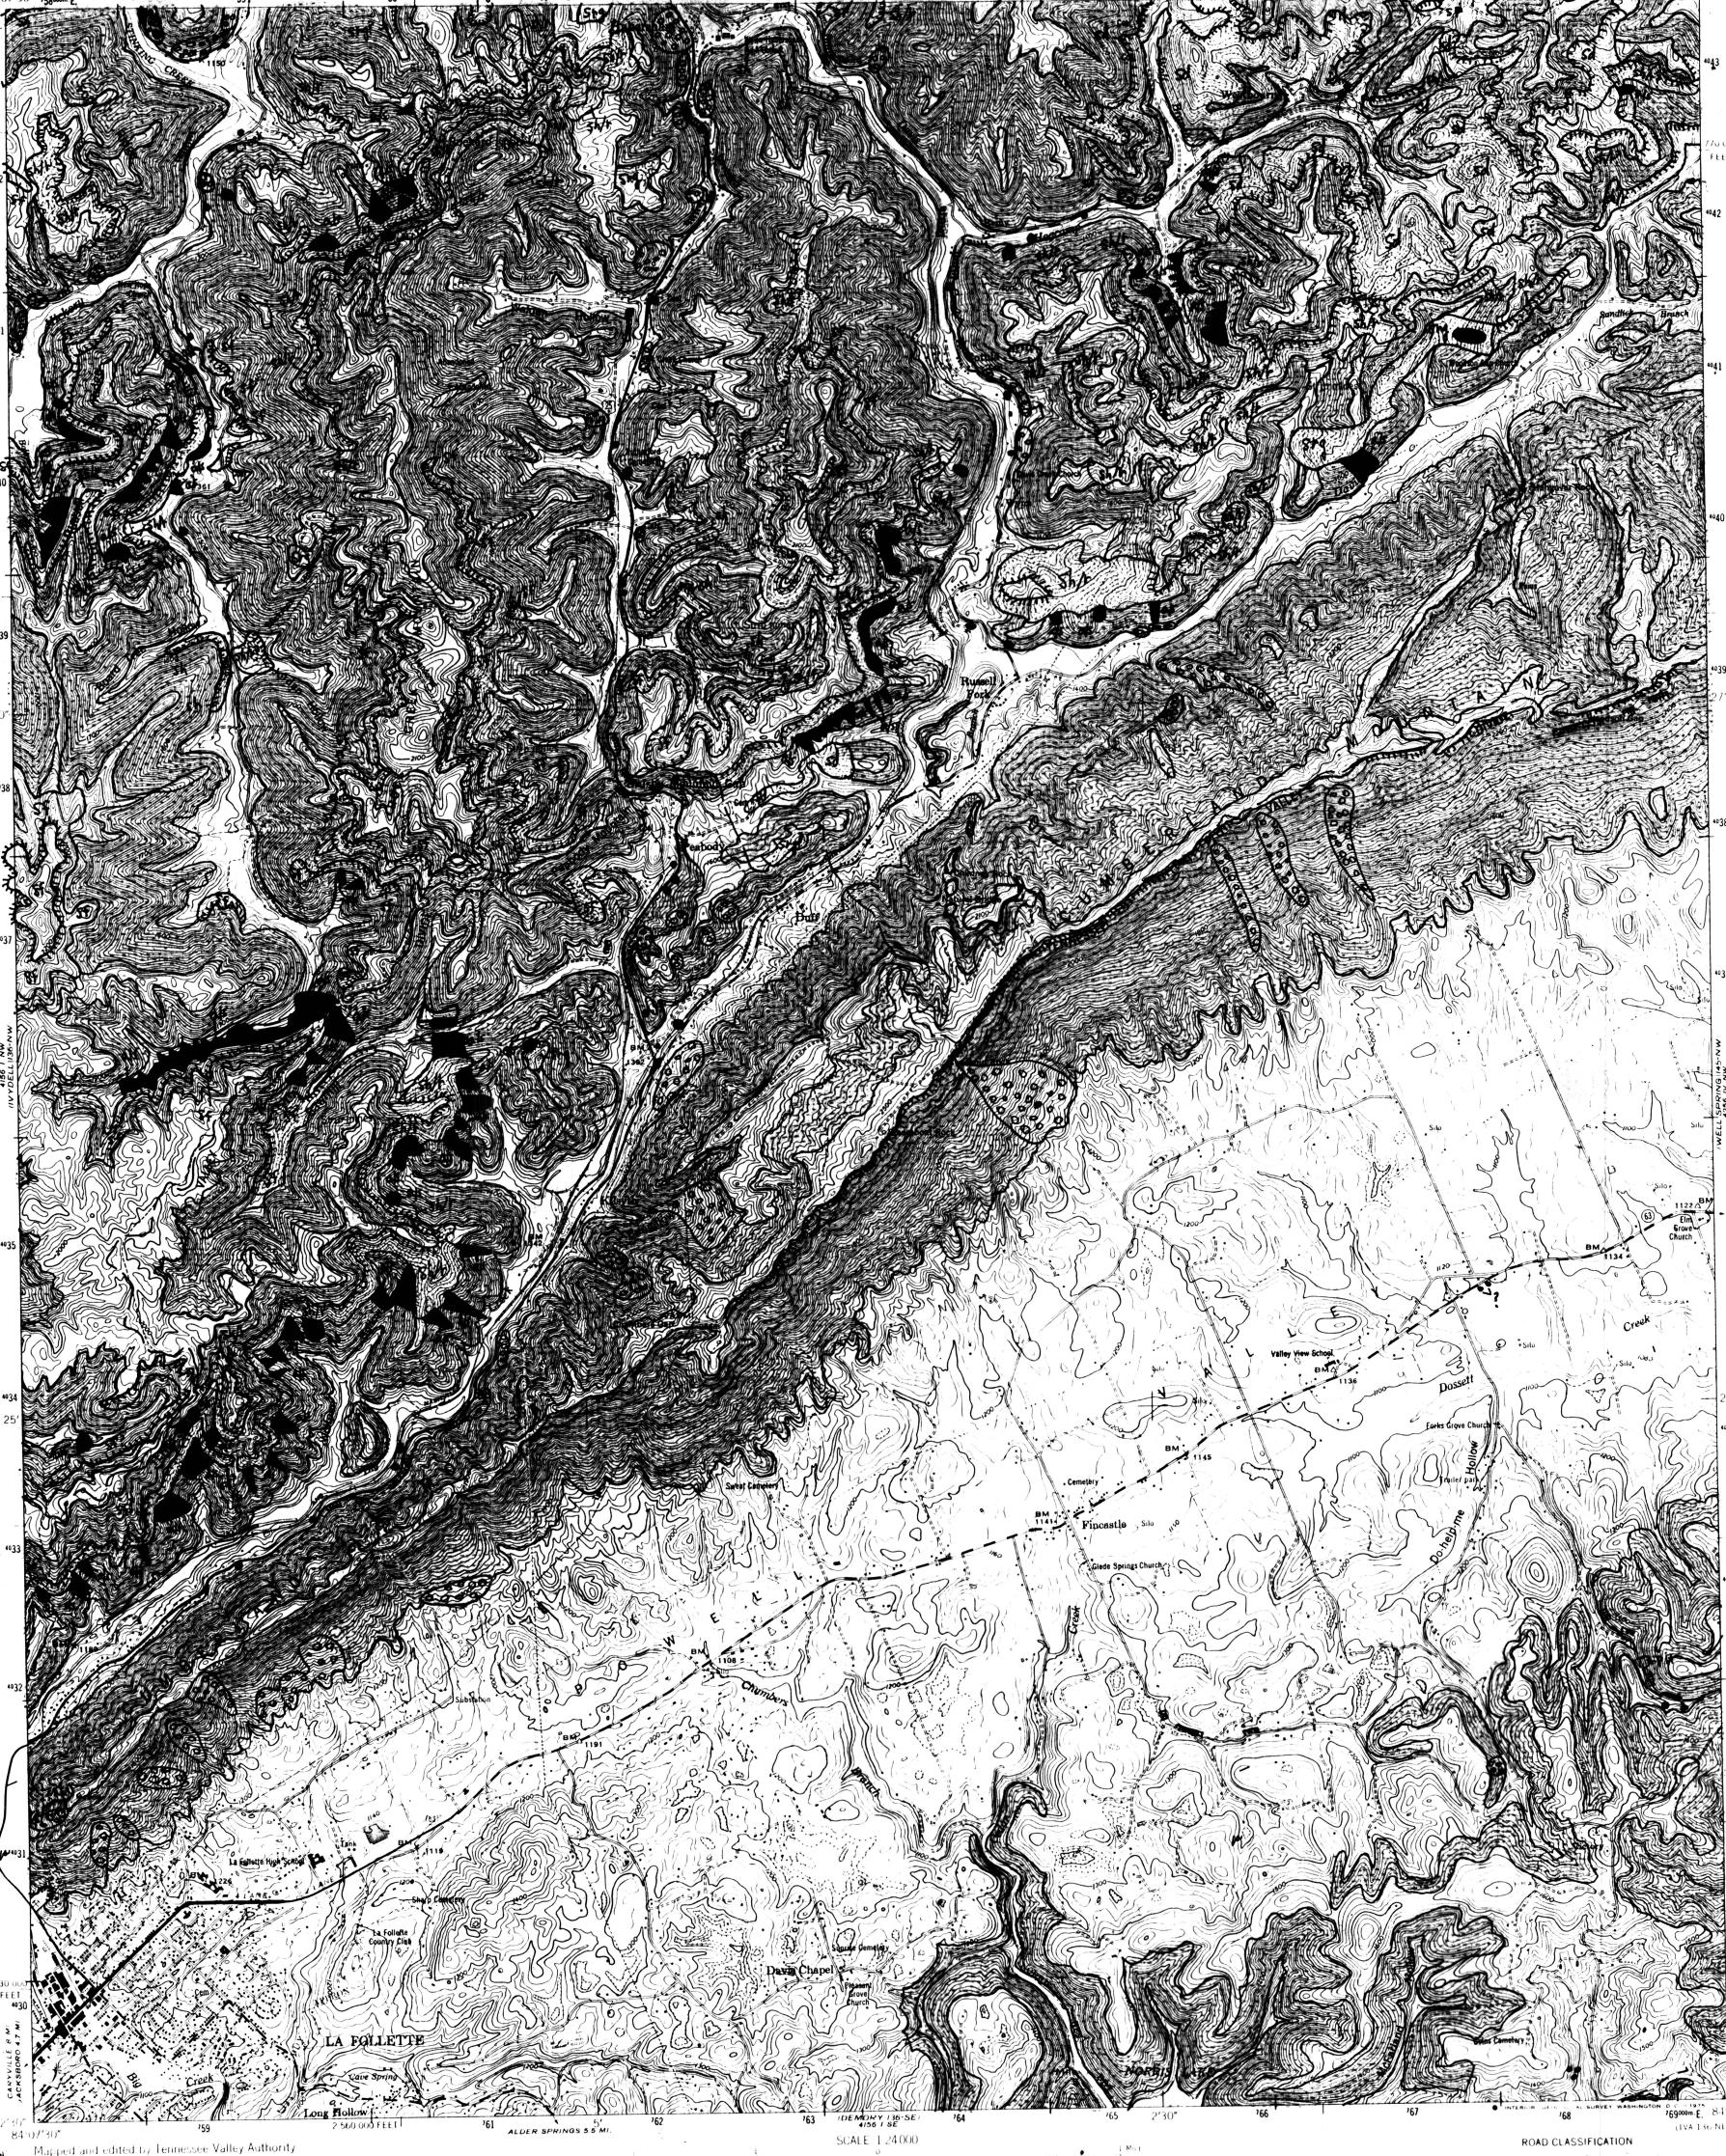
ACTIVE OR RECENTLY ACTIVE LANDSLIDE Complex landslide composed of earthflow, debris slide, earth and rock slump. Identified from historical records, and from scars, debris and other field evidence. Ground extremely unstable; sliding accelerated by excavation, loading and changes in drainage conditions. May include areas with several active slides too small to

OLD LANDSLIDE Area of extensive hummocky ground caused by earthflow and earth and rock slump. Lacks clear evidence of active sliding. Relatively stable in natural, undisturbed state, generally not affected by small structures properly sited in areas away from the edge of the toe; can be reactivated by extensive, rapid excavation, loading, and changes in ground water and surface water conditions. Area of old landslide probably includes recent ones not identified from field evidence or otherwise documented. Upslope boundary of landslide generally defined

COLLUVIAL SLOPE Valley wall along major streams with slope as steep as 40° (85%); stony, clayey silt soil up to 50 ft. (15 m) thick; commonly buttressed by a terrace or bench at the toe of the slope; very susceptible to sliding by cutting of toe area, removal of terrace or bench, and overloading;

AREAS SUSCEPTIBLE TO DEBRIS FLOWS AND DEBRIS **AVALANCHES** Primarily shallow, narrow ravines and chutes with accumulation of stony colluvium generally 10 ft. (3 m) or less in thickness; susceptible to rapid

AREAS SUSCEPTIBLE TO ROCKFALL Steep, locally vertical, natural and man-made slopes and cliffs, 15 ft. (4.5 m) or more high;

SOIL AND ROCK SUSCEPTIBLE TO LANDSLIDING Soil and rock similar to that involved in landslides elsewhere in map area; primarily areas underlain by claystone, mudstone and shale associated with other rock types. Rock weathers rapidly on exposure forming clayey soil highly susceptible to sliding. Includes coves (U-shaped, shallow valleys) containing thick layers of clayey soil that are very susceptible to sliding where excavation breaks continuity of slope and where overloaded by artificial fill.

AREAS LEAST PRONE TO LANDSLIDES Map areas in which no patterns or symbols are shown; primarily valley floors, ridge tops and broad benches; modification by excavation and fill may
